**RE: Long-Term Operations and Maintenance Annual Report (Soil Remedy)  
South Cavalcade Superfund Site – Concrete Cap**

This letter and attachments serve as the 2001 Long-Term Operations and Maintenance Annual Report (Report) for the soil remedy of the South Cavalcade Site located in Houston, Texas. This report is submitted to the Environmental Protection Agency as required by the Remedial Action Work Plan for the South Cavalcade Site on behalf of Beazer East, Inc.

**Project Name/ Client:**  
South Cavalcade Long-Term O&M  
Annual Report

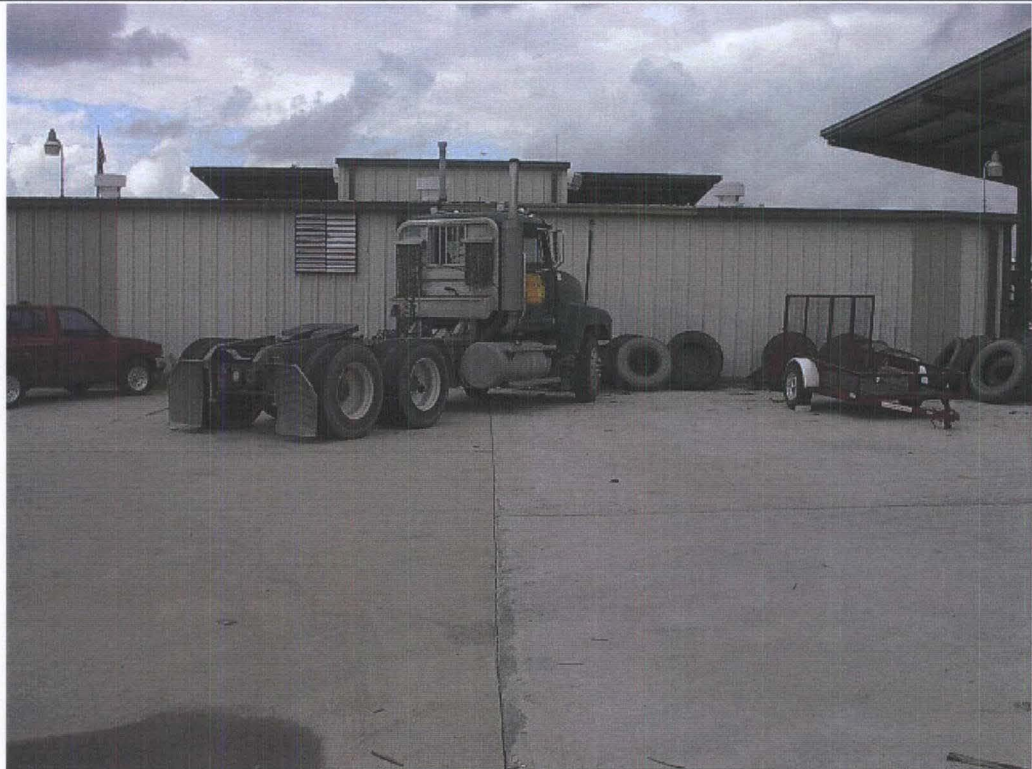
**Photo No.**  
1

Photo shows on-site tire shop and typical condition of cap pavement and joint system. In basin 4 of the southeast area at the approximate location of cap and pavement.

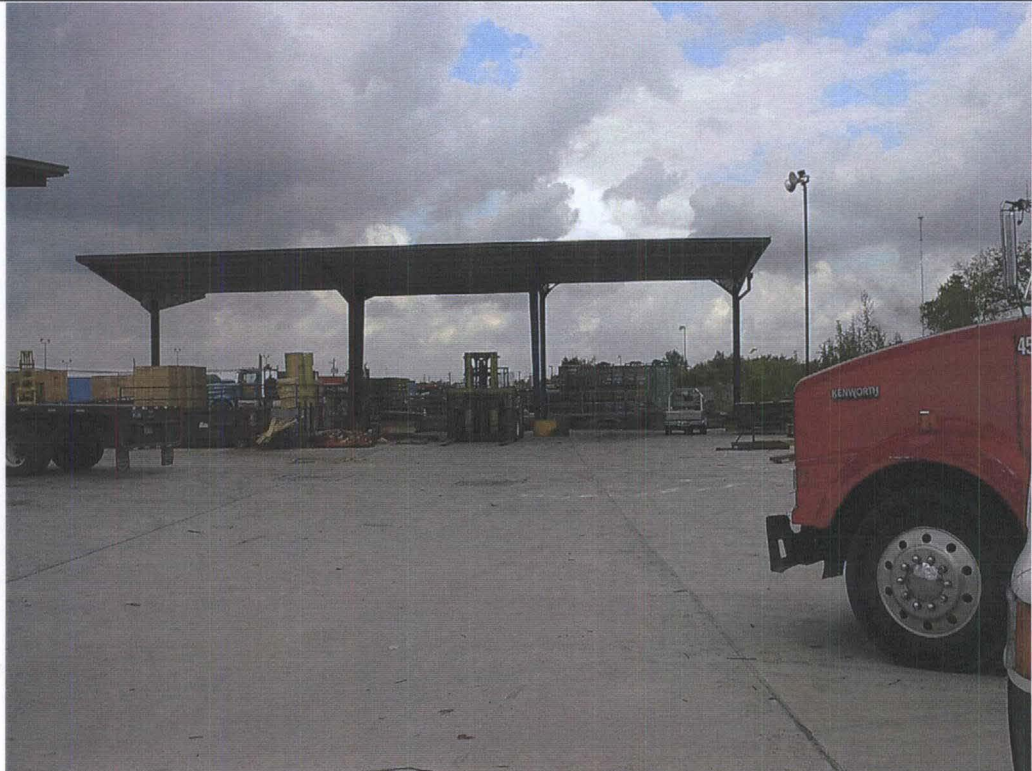
**Photo No.**  
2

Photo shows basin 4 of southeast area concrete and joints.

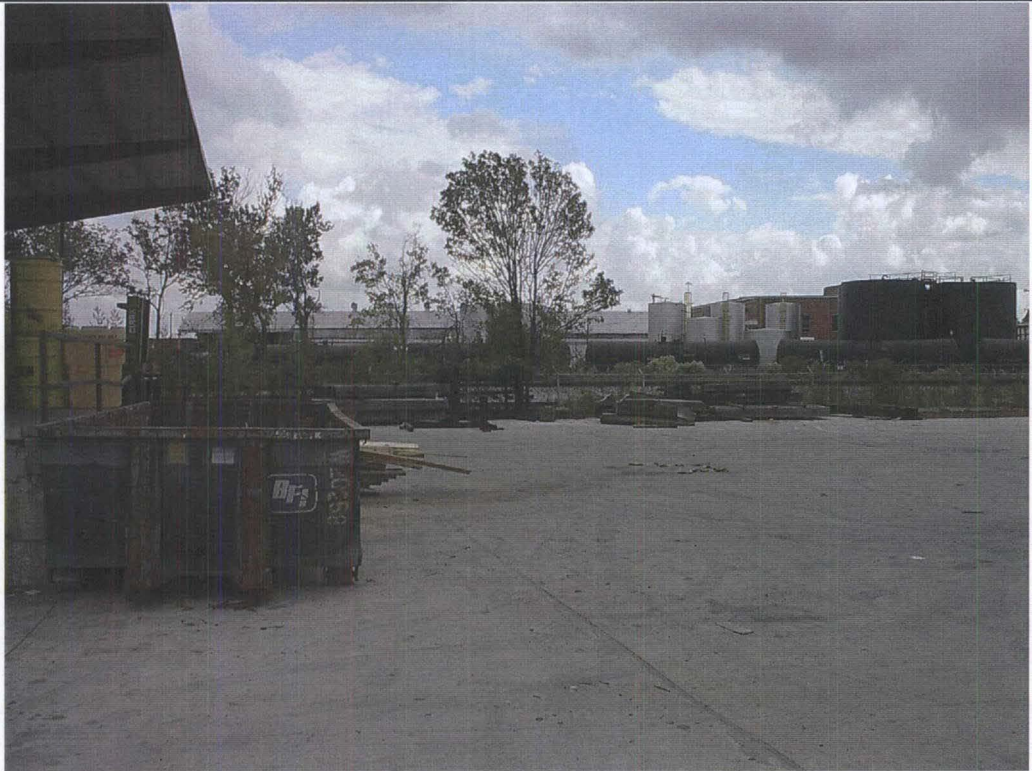
3

Basin 4 concrete cap and  
joint. Photo also shows  
typical use of cap in  
southeast area.

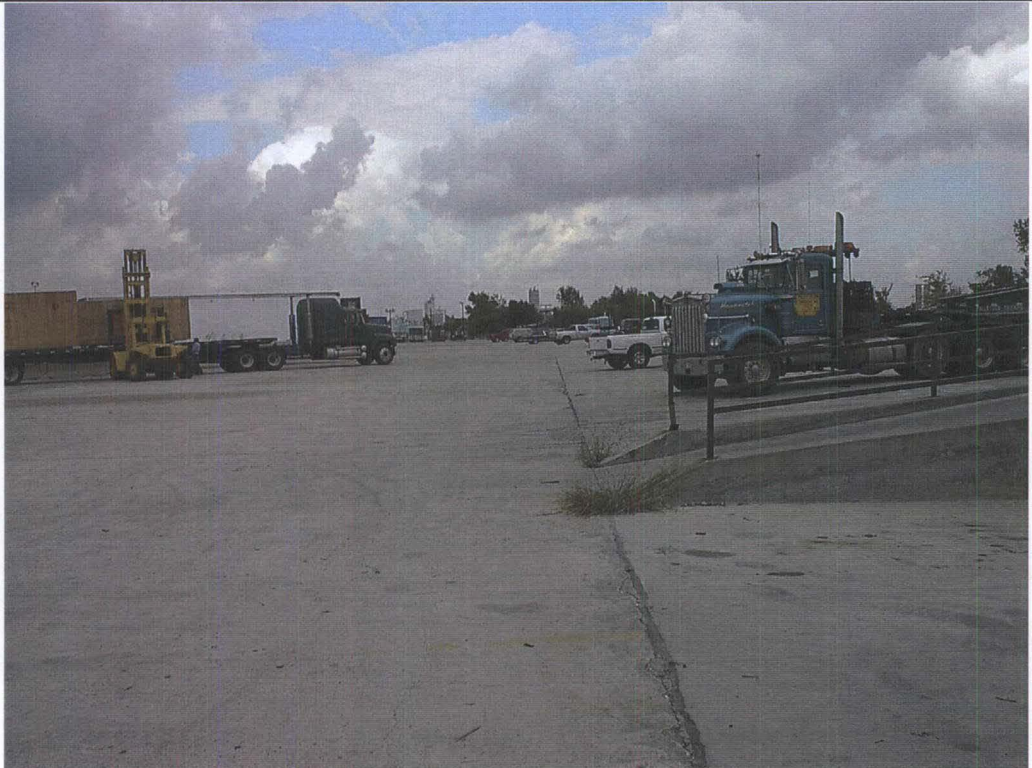
From basin 4 in southeast  
area along existing  
pavement and concrete  
cap edge at ramp.

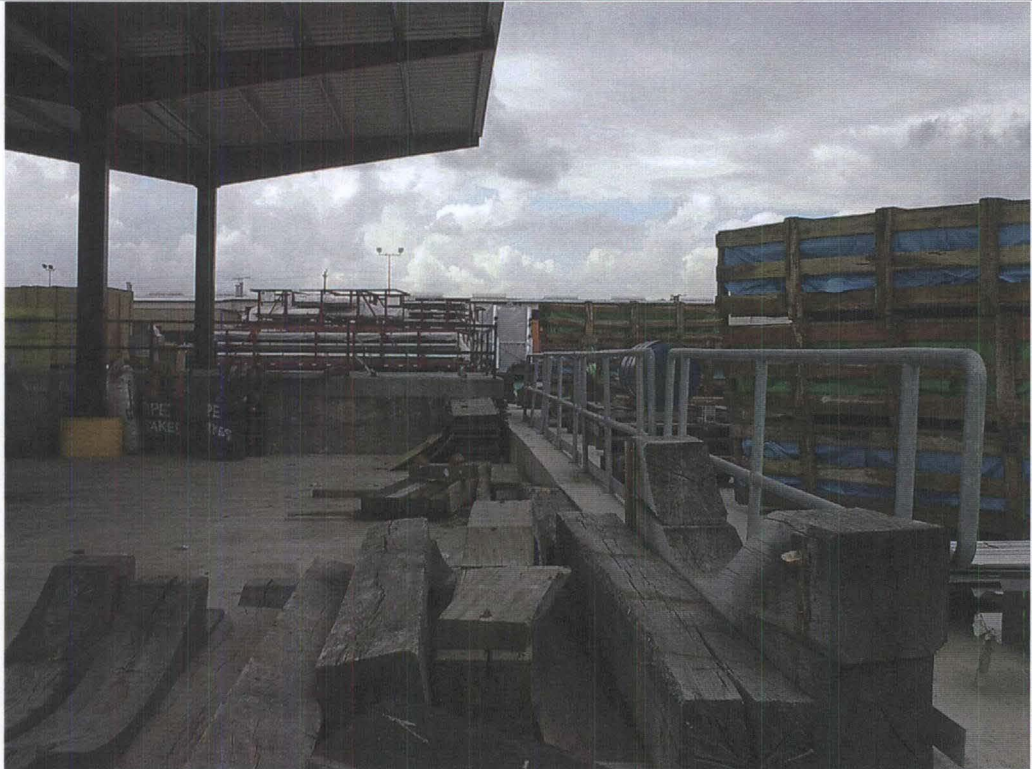
**Photo No.**  
5

At basin 4 and 3 interface along eastern property line in southeast area. Cap area shown is being used for storage.

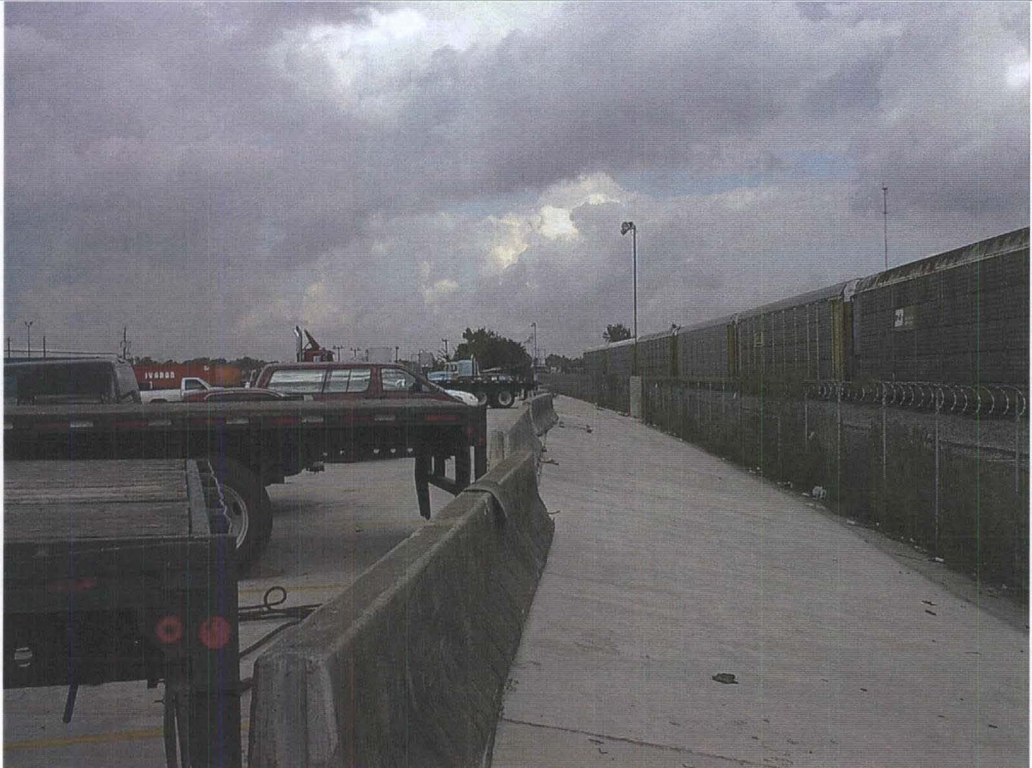
**Photo No.**  
6

At basin 3 in southeast area along slope pavement near property line. Concrete is in good condition.

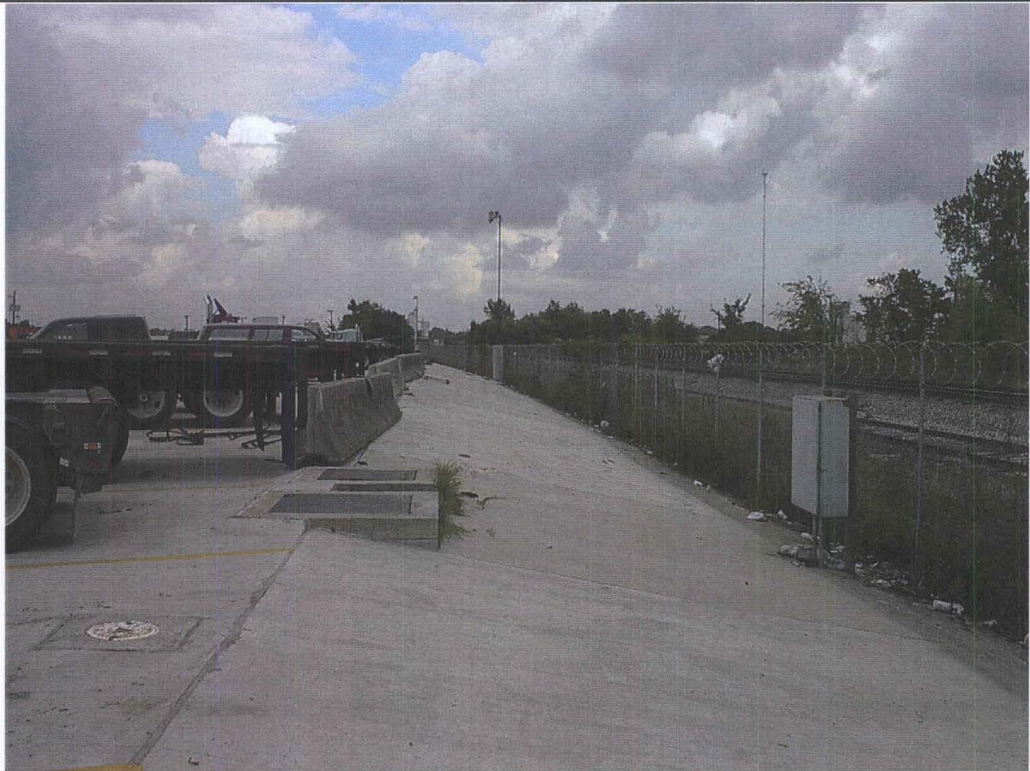
**Photo No.**  
7

Photo taken along slope  
pavement in southeast  
area at the existing utility  
box location.

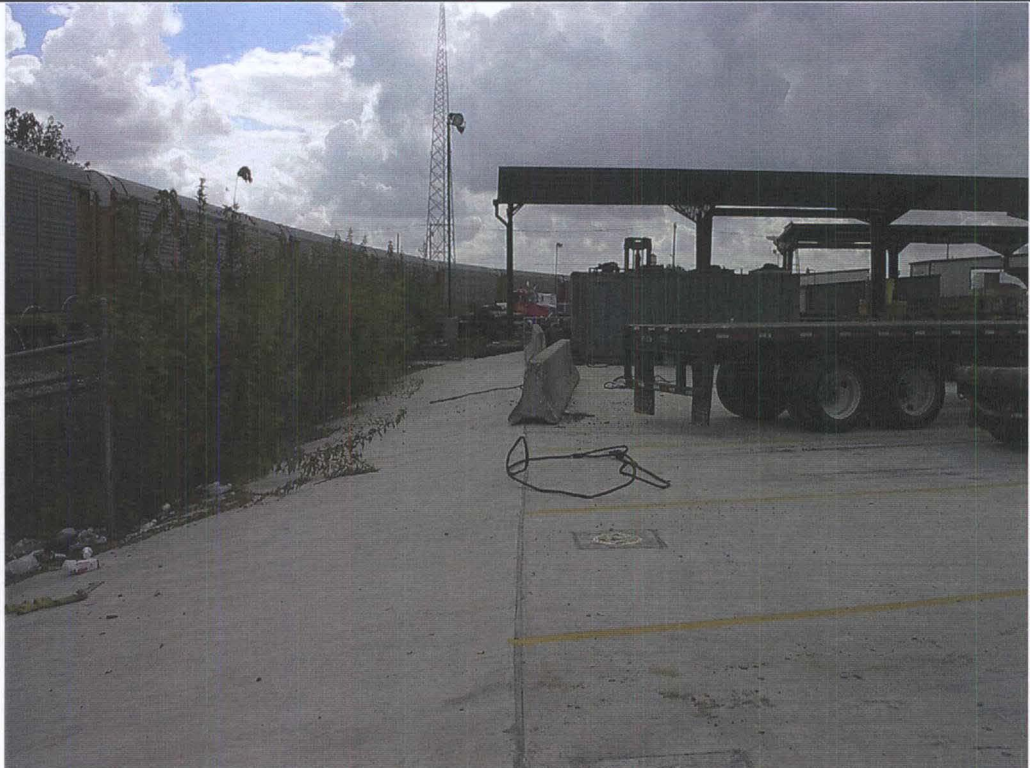
**Photo No.**  
8

From basin 3 in southeast  
area along property line.  
Photo shows slope  
paving.

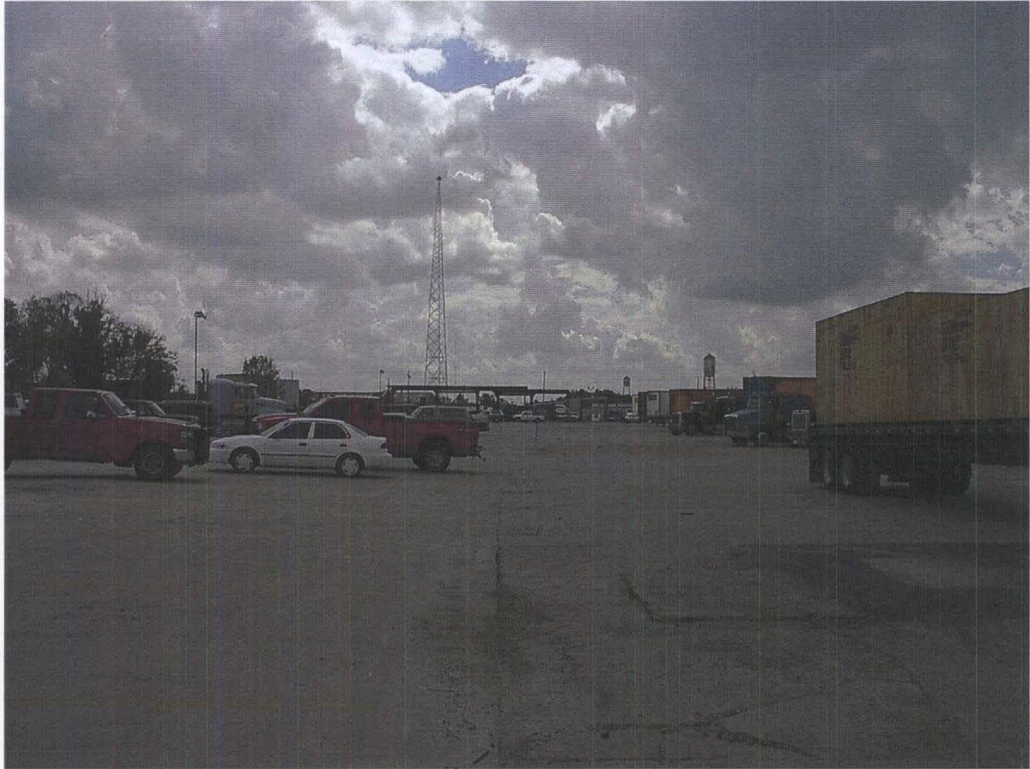
**Photo No.**  
9

From basin 1 towards  
basin 2 in southeast area  
along the edge of existing  
pavement and concrete  
cap.

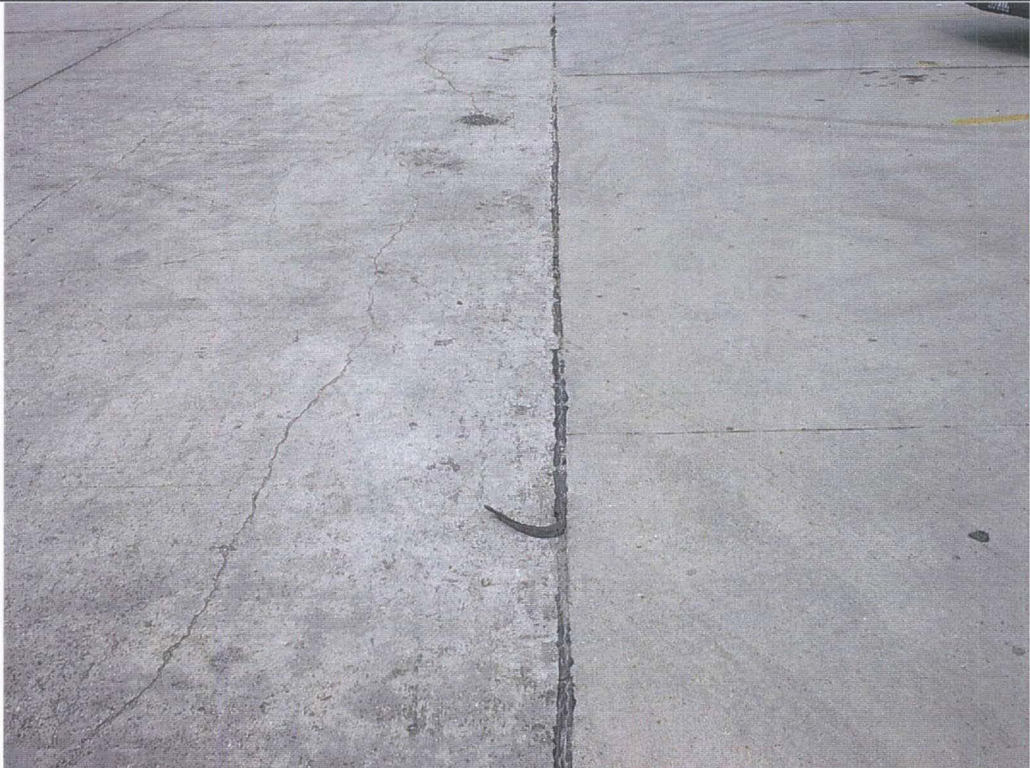
**Photo No.**  
10

Photo shows joint  
between concrete cap and  
previously existing  
concrete pavement in  
southeast area. The joint  
material has detached and  
come out of the joint.

Based on the results of the property owner conversations and the site inspection limited additional maintenance should be performed at the site. As indicated in Photo 10, approximately 6 inches of joint material in the southeast area has become dislodged. This minor maintenance issue will not affect the performance of the design remedy with respect to the ability provide the protection specified by the ROD. By copy of this letter report, the appropriate property owners are notified of this maintenance issue.

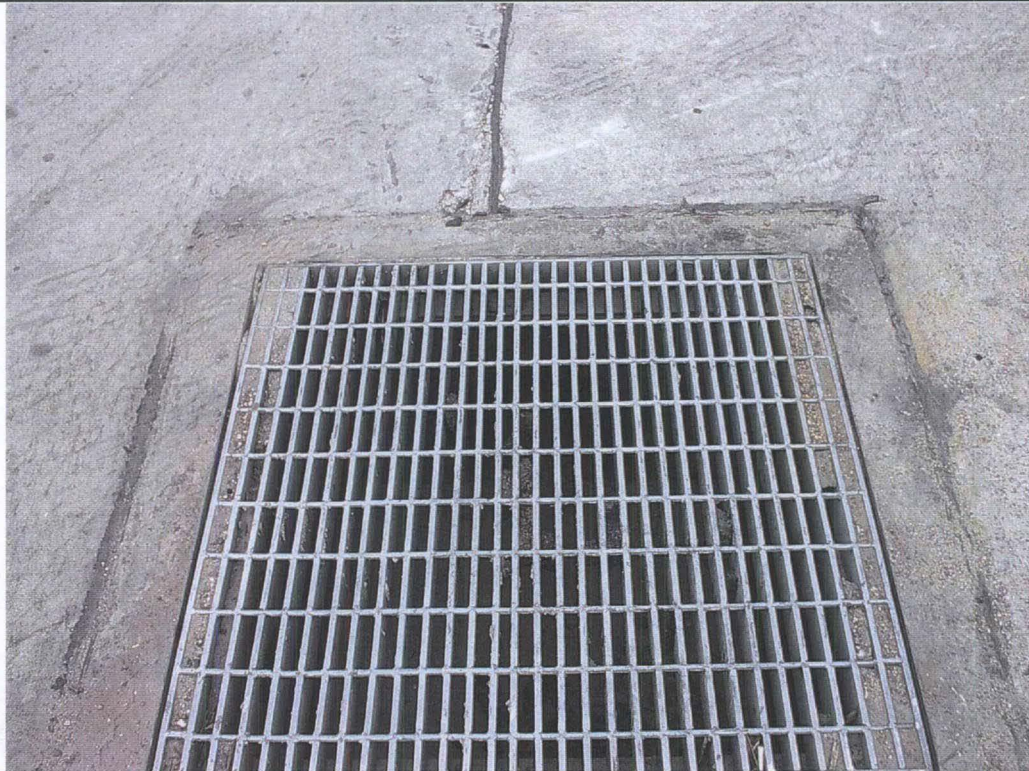
**Photo No.**  
11

Photo shows typical  
condition of stormwater  
inlets and concrete joint  
material surrounding  
inlets.

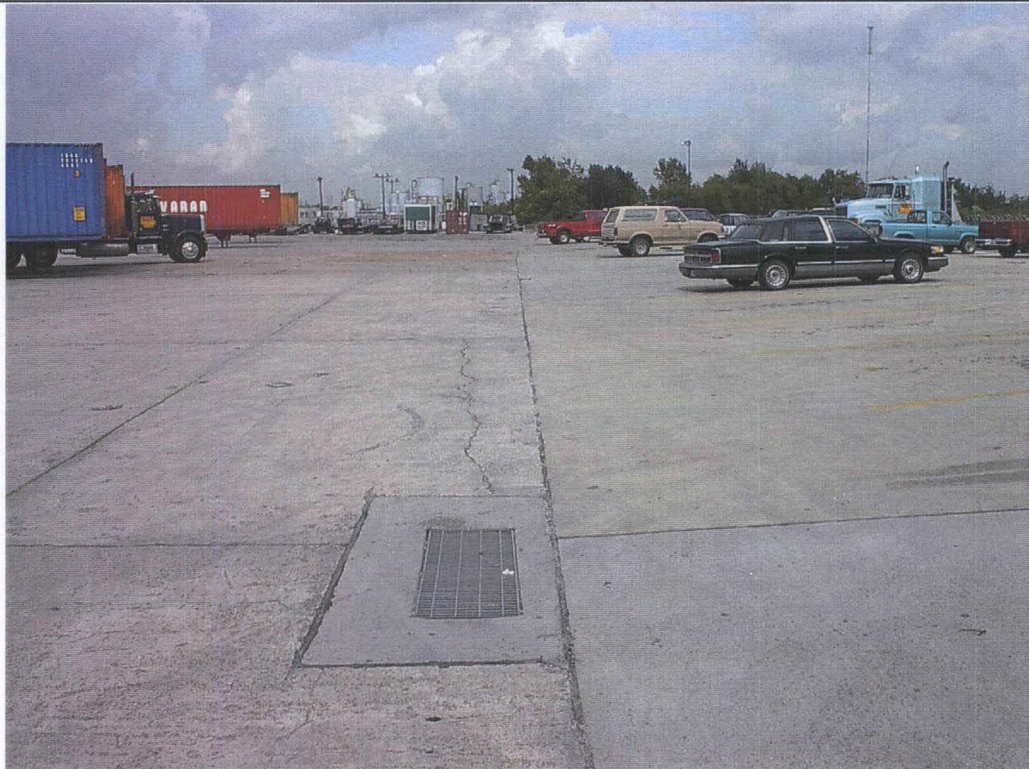
**Photo No.**  
12

From basin 2 towards  
basin 1. In southeast area.  
Photo shows stormwater  
inlet and condition of  
concrete cap (to the right).  
Joint system appears to  
be good repair.

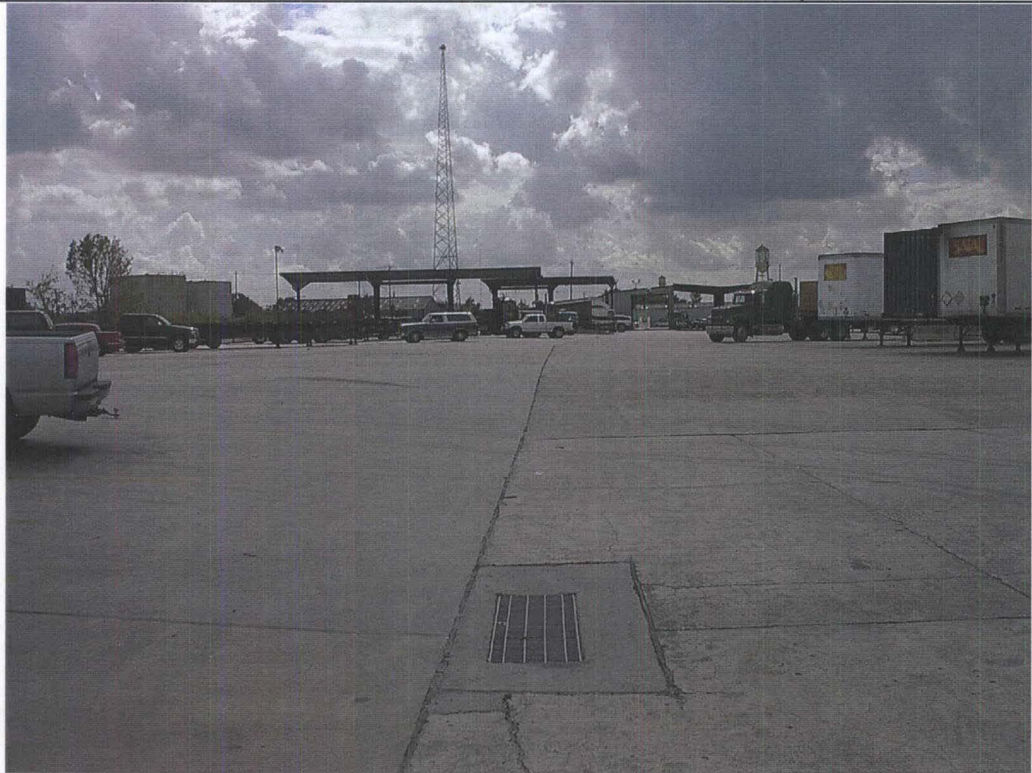
**Photo No.**  
13

From basin 2 towards basin 3 in southeast area. Photo shows concrete cap and existing pavement and stormwater inlet.

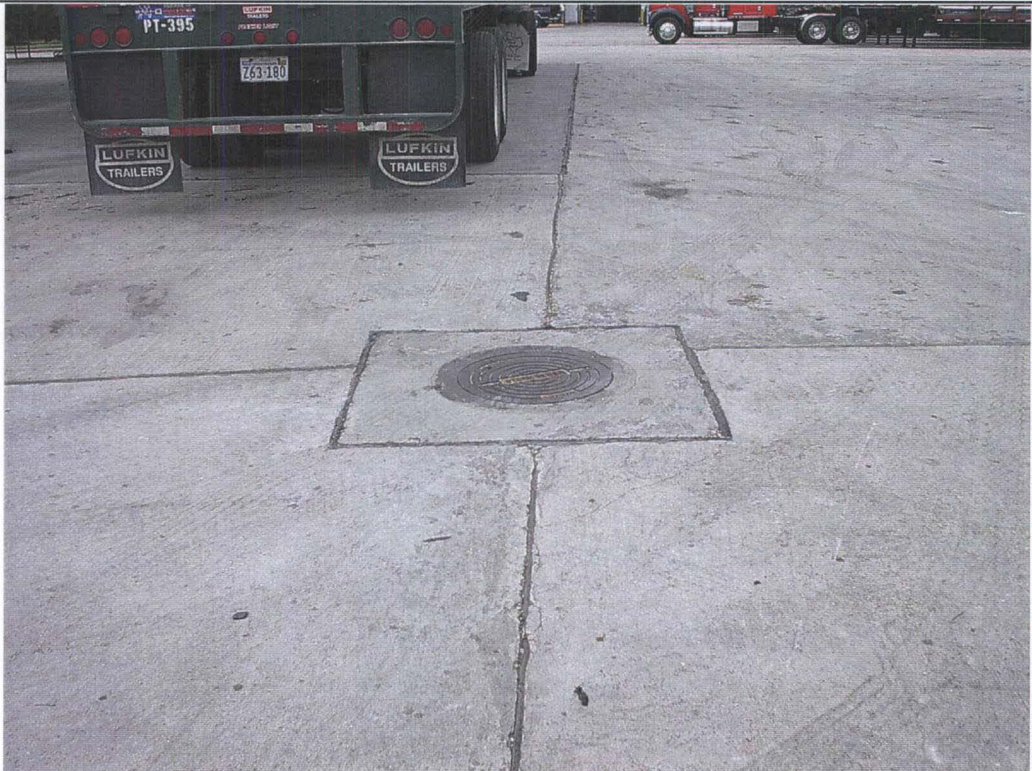
**Photo No.**  
14

Photo shows typical condition of manholes in southeast area.

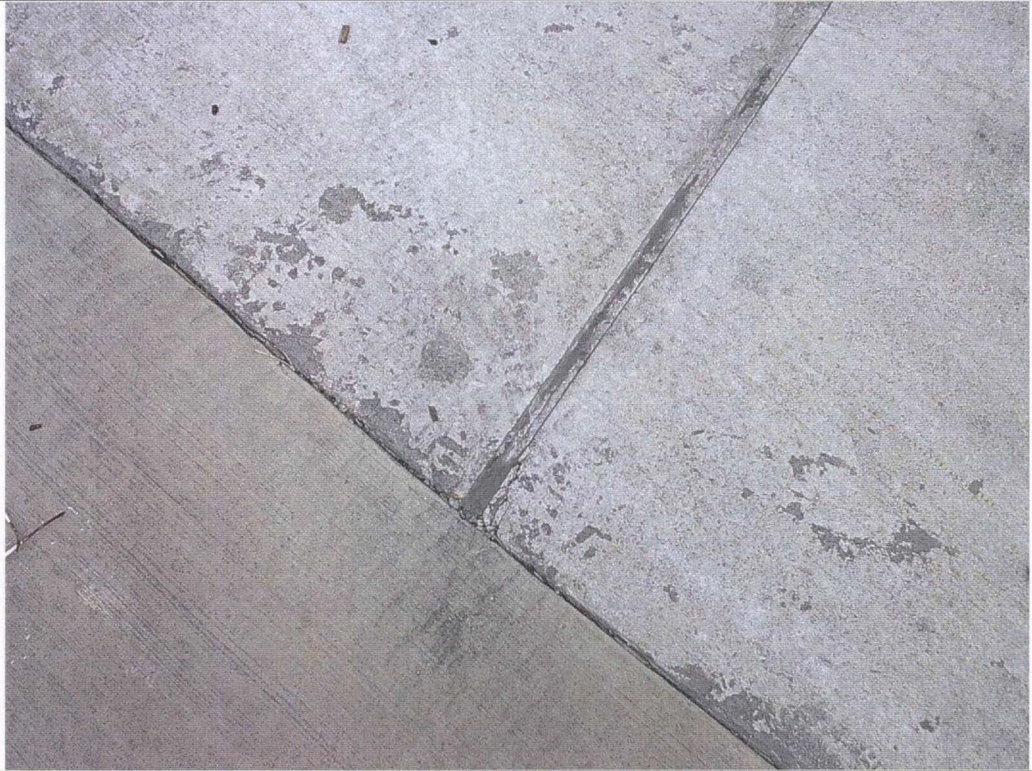
**Photo No.**  
15

Photo shows typical joints  
of concrete cap. Some  
minor spalling has  
occurred at joints.  
Spalling pattern is typical  
of concrete construction.

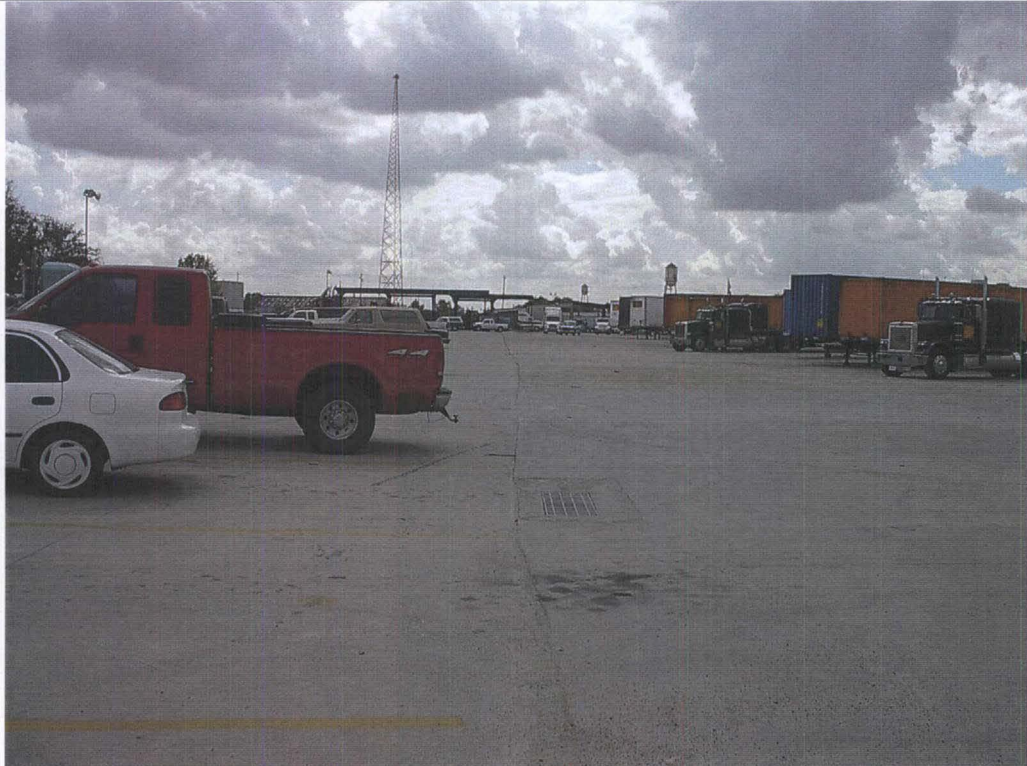
**Photo No.**  
16

Photo taken along existing  
pavement edge with  
concrete cap. Typical use  
of cap in southeast area  
for parking is shown.

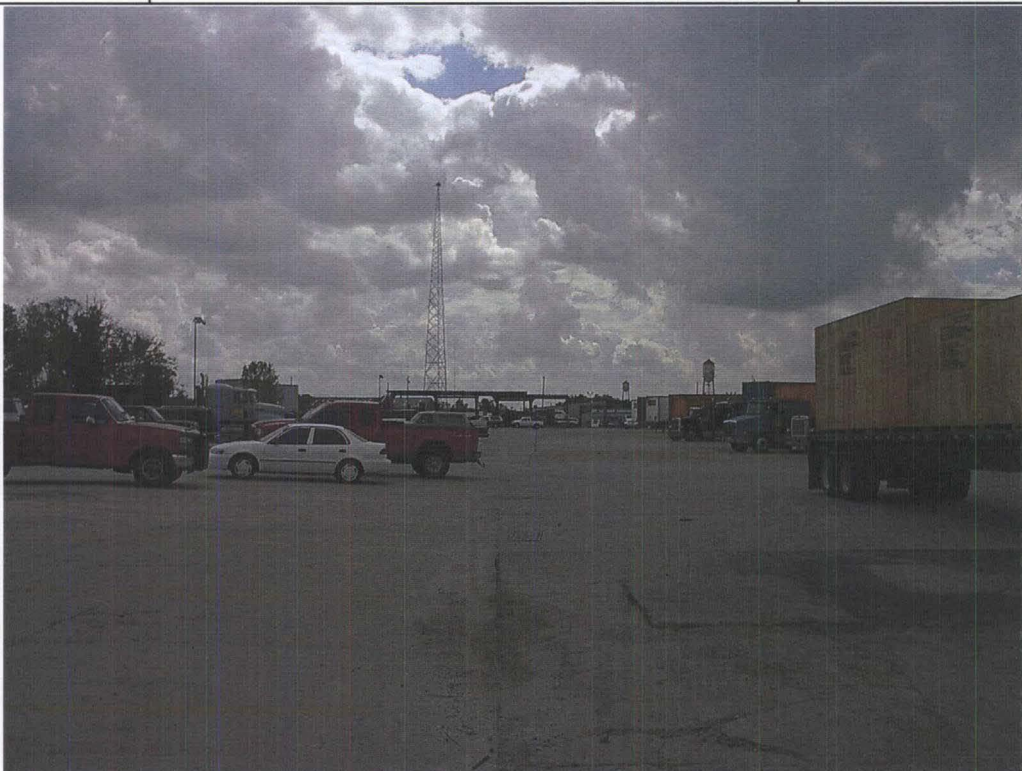
17

Similar to photo 16.  
Shows concrete cap and  
adjacent pavement in  
southeast area. Photo is  
taken from the northern  
end of basin 1.

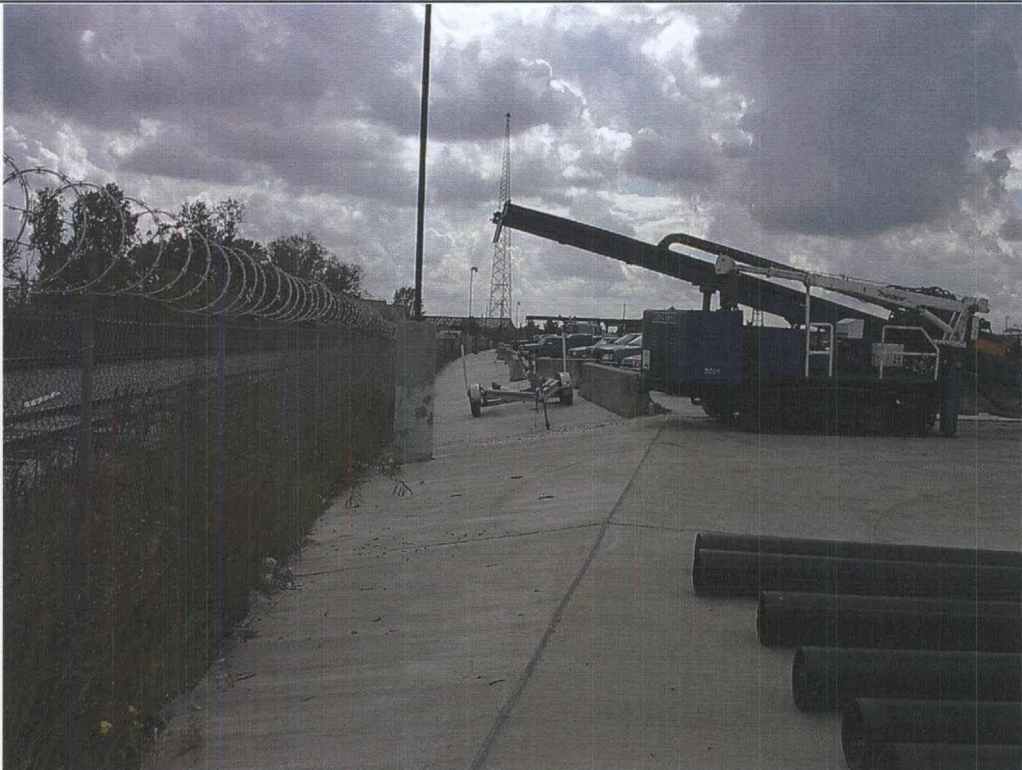
18

Photo shows slope  
pavement that connects to  
concrete cap at the  
northern end of concrete  
cap in the southeast area.

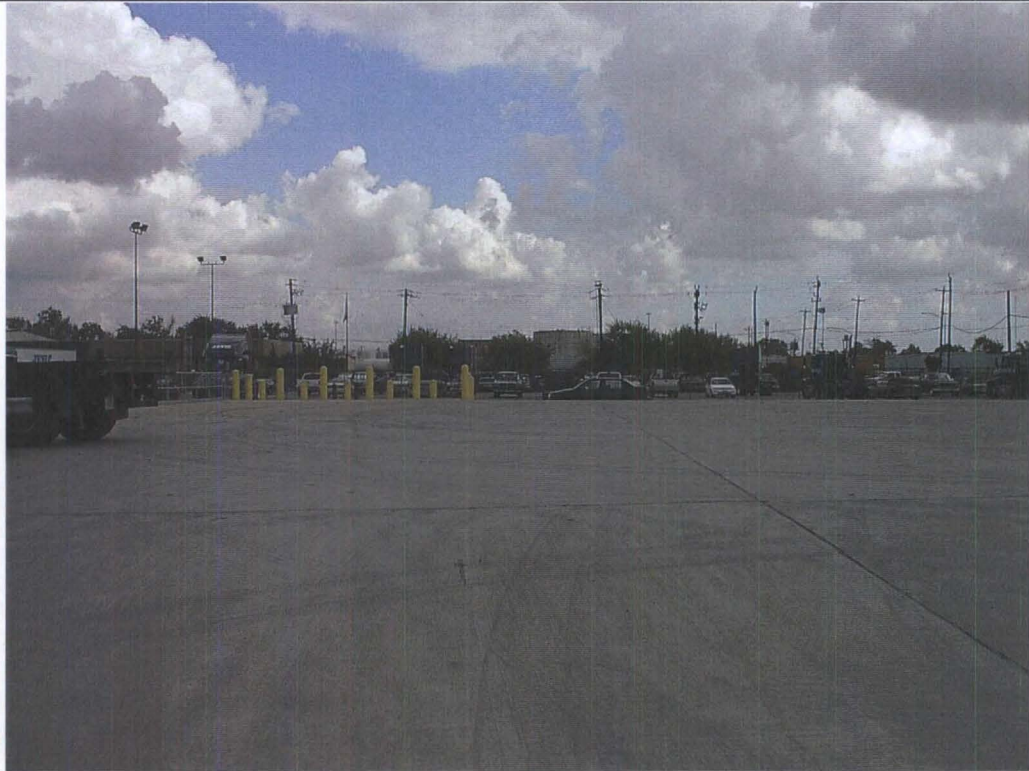
19

Photo taken on the  
concrete cap in the  
southwest area. Photo  
shows protective bollards  
in the northeast corner of  
cap.

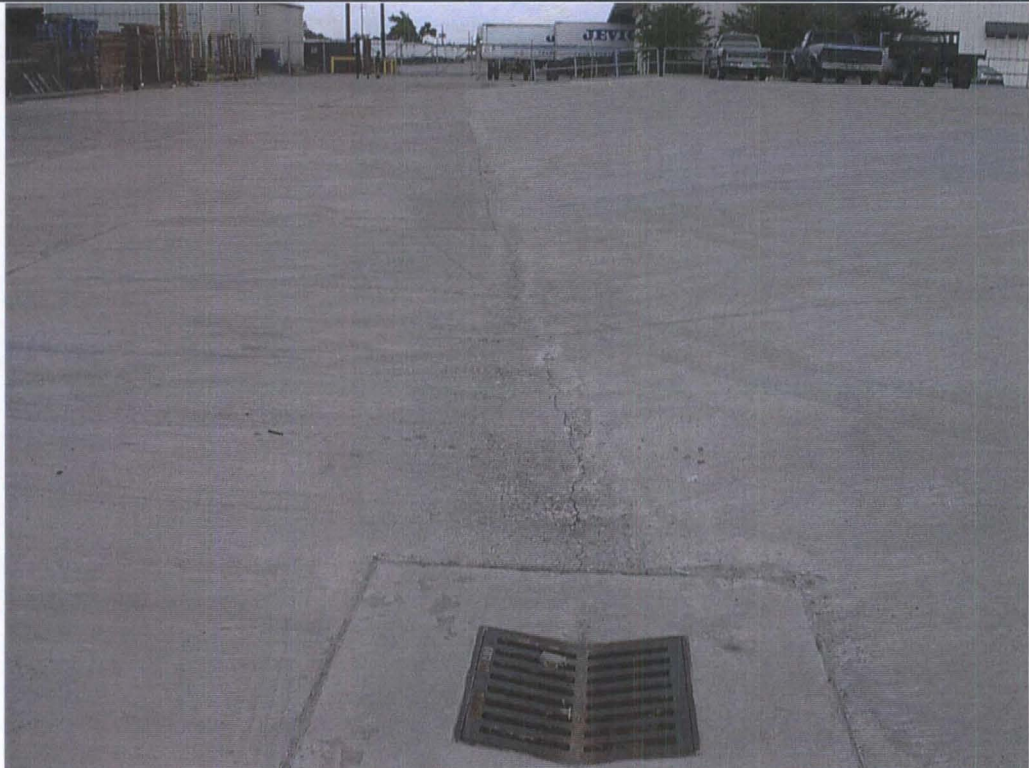
20

Photo shows cracking  
along the edge of  
concrete cap towards  
stormwater inlet. Crack is  
along the concrete cap  
and is a typical of an  
contraction crack that  
occurred during curing.

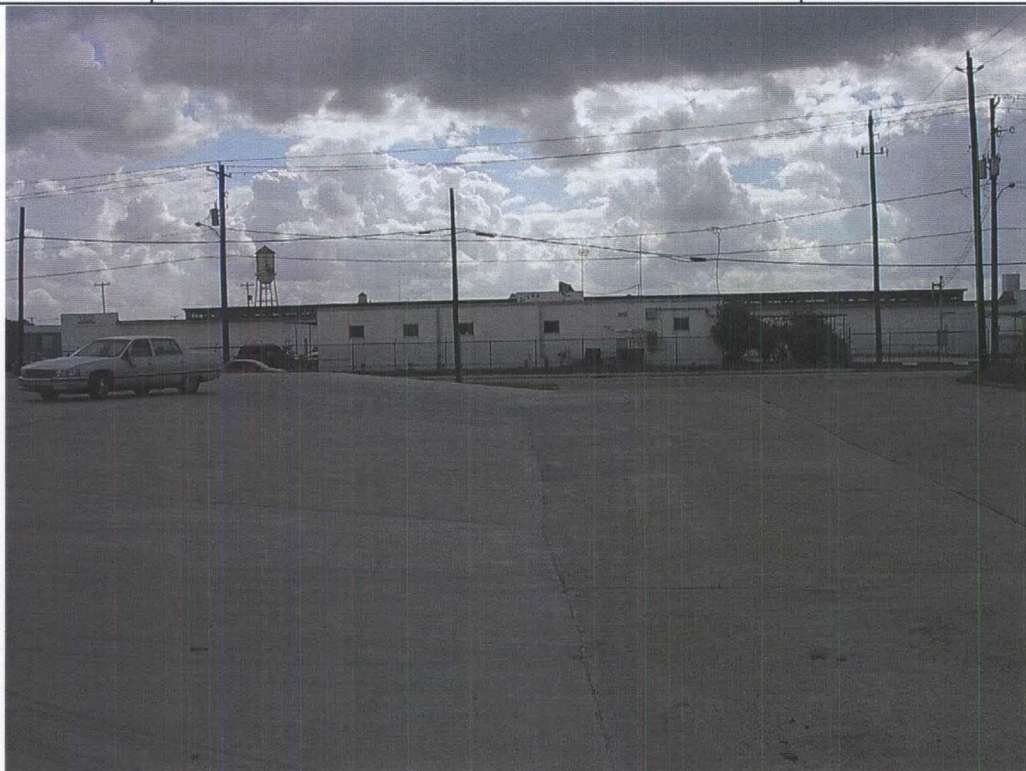
21

Photo taken along the  
western edge of concrete  
cap in the southwest area.  
Joint is in good condition.
